Brazed Aluminum Heat Exchanger Dashboards

SJOERD HOOGWATER PHILLIPS 66 COMPANY MIDSTREAM OPERATIONS

May 2024

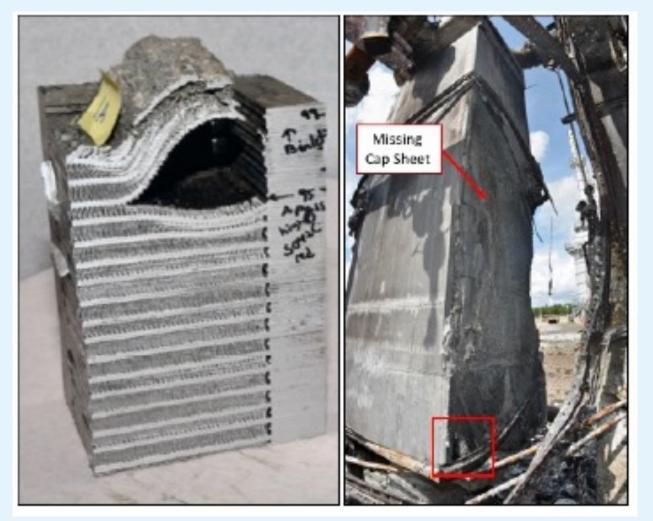
BAHX Damage

Source: Chemical Safety Board (CSB) report No. 2016-02-I-MS Figure 12, page 21

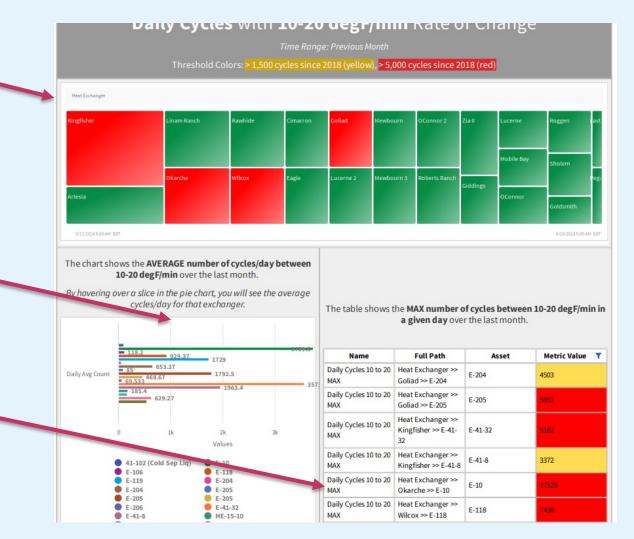
Dashboard (Thermal Cycles)

- <u>Treemap</u> shows which facilities need attention
- <u>Bar Chart</u> shows which exchangers had a lot of cycles over the last month
- <u>Table shows</u> which exchangers had the most cycles during one particular day
